BioBond Antimicrobial Protective Floor and Wall Coating April 2025

Case Study: *Nova Farms (Phoenix, Arizona)*

19,600 Sqft Food Processing and Distribution Center

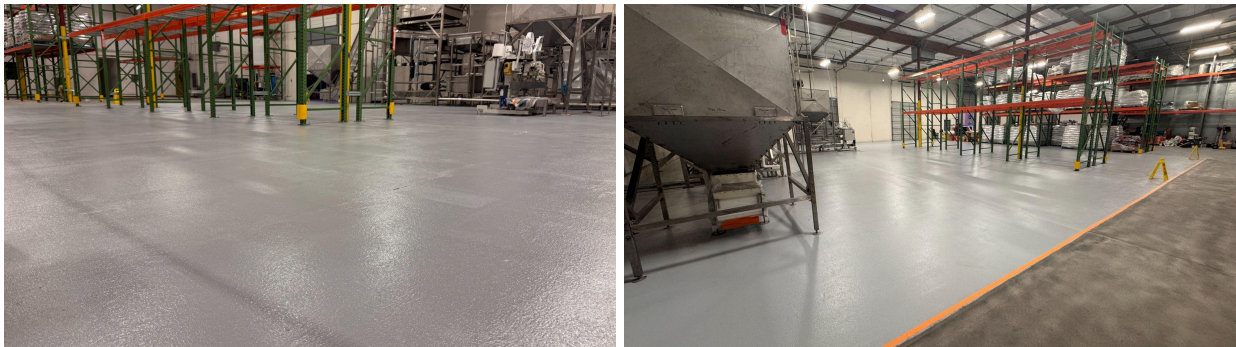
Next came the application of **BioCoat SSoE250**, a biobased base coat designed to fill in cracks and create a smooth foundation. The final layer, **BioCoat SUP250**, is a USDA BioPreferred-certified, antimicrobial urethane topcoat that contains **zero microplastics** as well as no odors. Together, these three layers form the only biobased, triple-coat flooring system on the market today—delivering long-lasting protection with antimicrobial properties that can remain effective for 20–30 years, depending on the wear of the topcoat.

On four weekends in a row, BioBond and a contractor crew were on site at Nova Farms Food Processing and Distribution facility in Phoenix, Arizona to apply BioBond's Antimicrobial, Antislip Protective Coatings. Under the supervision of the BioBond team, the job began by preparing the target floor by grinding and filling cracks. It is critical to have a floor that is well prepared for coatings. The contractor then began by applying BioCoat SWaE250, a biobased primer epoxy that ensures strong adhesion between the concrete and the next layer.

The result? A durable floor that is anti-slip to add to the safety of the employees, with no downtime of the facility as no unpleasant odors were present. Food Processing and Distribution centers must apply a coating to their floors, so now this facility has a protective antimicrobial coating ready for inspection
